# **EXHIBIT I**

# Materials Characterization of Explanted Polypropylene Hernia Meshes

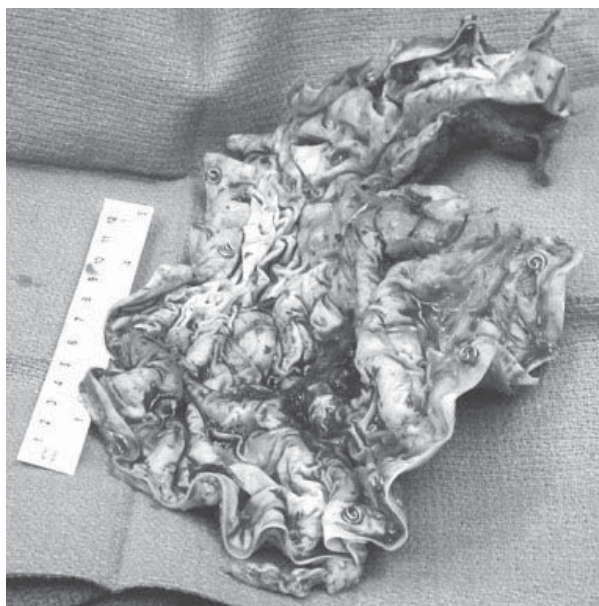
**Figure 1.** Kugel Composix hernia mesh immediately after explantation.

Polypropylene hernia repair materials were removed from patients requiring revision surgery due to chronic pain, recurrence, infection, adhesions, or other complications. An example of an explanted mesh is shown in Figure 1, and the contraction and embrittlement of the material are evident. The study was approved by the University of Missouri-Columbia's IRB committee, and each explant was given a sequential specimen number unrelated to any identifiable patient data. All 14 samples included in this study were the polypropylene components from polypropylene/expanded polytetrafluoroethylene composite hernia mesh such as Composix E/X or Kugel Composix (C.R. Bard, Cranston, RI), shown in Figure 2.

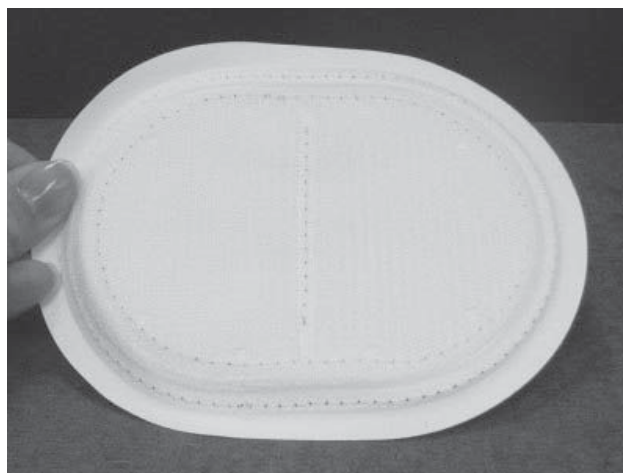
**Figure 2.** Pristine Kugel Composix hernia mesh.

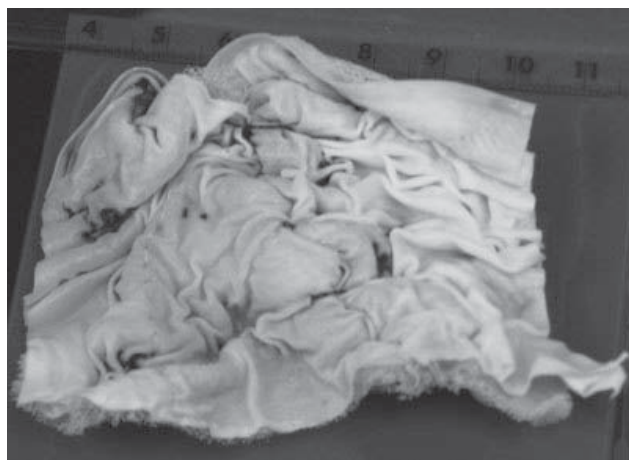
**Figure 3.** Explanted Kugel Composix hernia mesh after tissue removal.

is now shown in Figure 3 after the tissue has been removed. The mesh remains contracted, suggesting a permanent deformation of the material while *in vivo*. Pristine samples of a Composix E/X mesh (C.R. Bard, Cranston, RI) were also subjected to the same cleaning process and used in all subsequent tests for comparison with explanted samples.
